### **Technical Notification**

Document number: 97-131088

#### Condensation, Fleet Broadband antenna 3050A/C

Condensation in FBB antenna due to wrong installation.

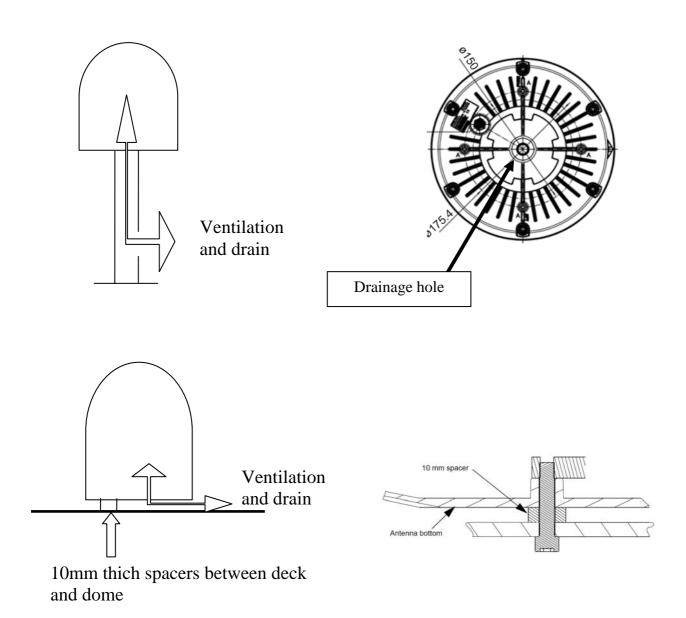
# Appendix I

Water damage due to blocked drainage hole or no clearance between the antenna and the hull.

**Note:** The drainage holes at the center of the antenna must have a clearance of 10 mm above the base plane, and **must NOT be blocked.** Use spacers to "lift" the antenna. If the base plane is curved, it may be necessary to place extra spacers to ensure the clearance of 10 mm.
